Hail Damages to Roof Systems #3 Modified Bitumen Roof Systems

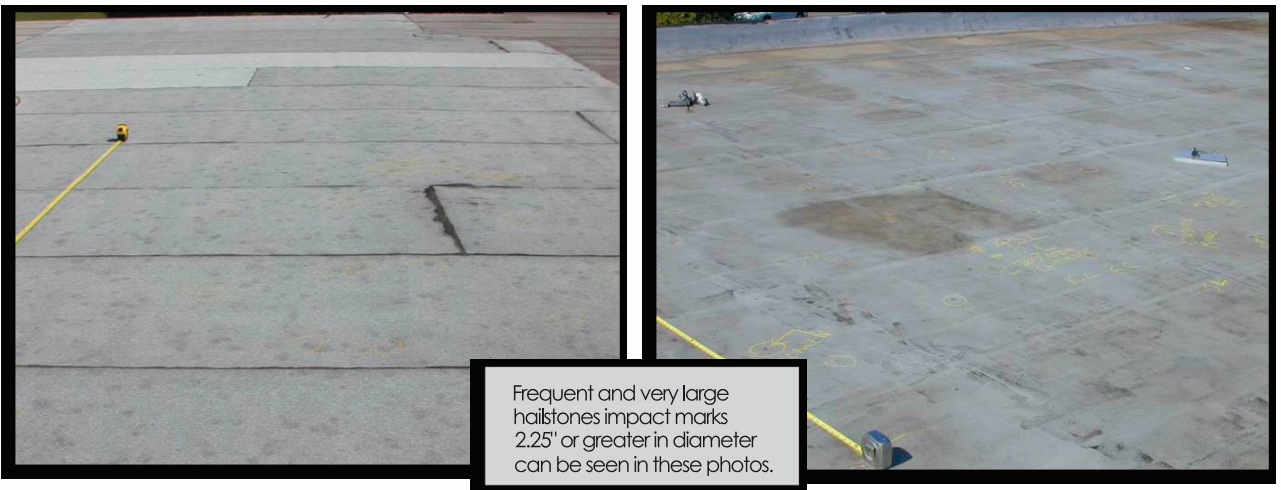
Frequent and very large hailstones impact marks 2.25" or greater in diameter can be seen in these photos.

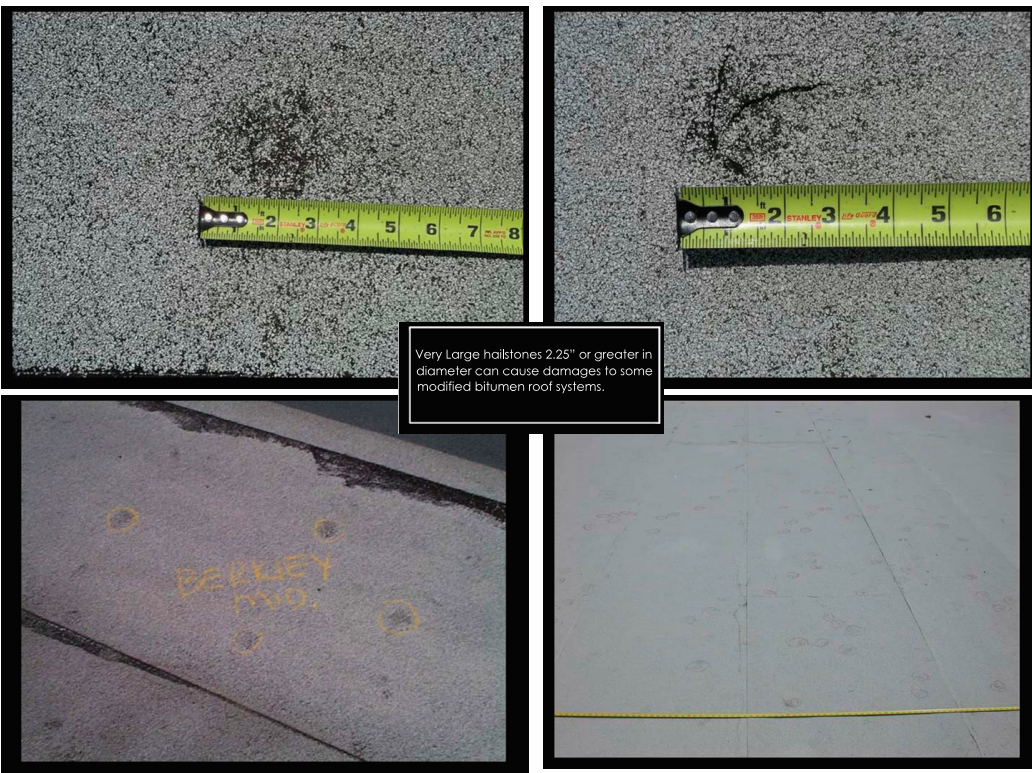
Very Large hailstones 2.25" or greater in diameter can cause damages to some modified bitumen roof systems.

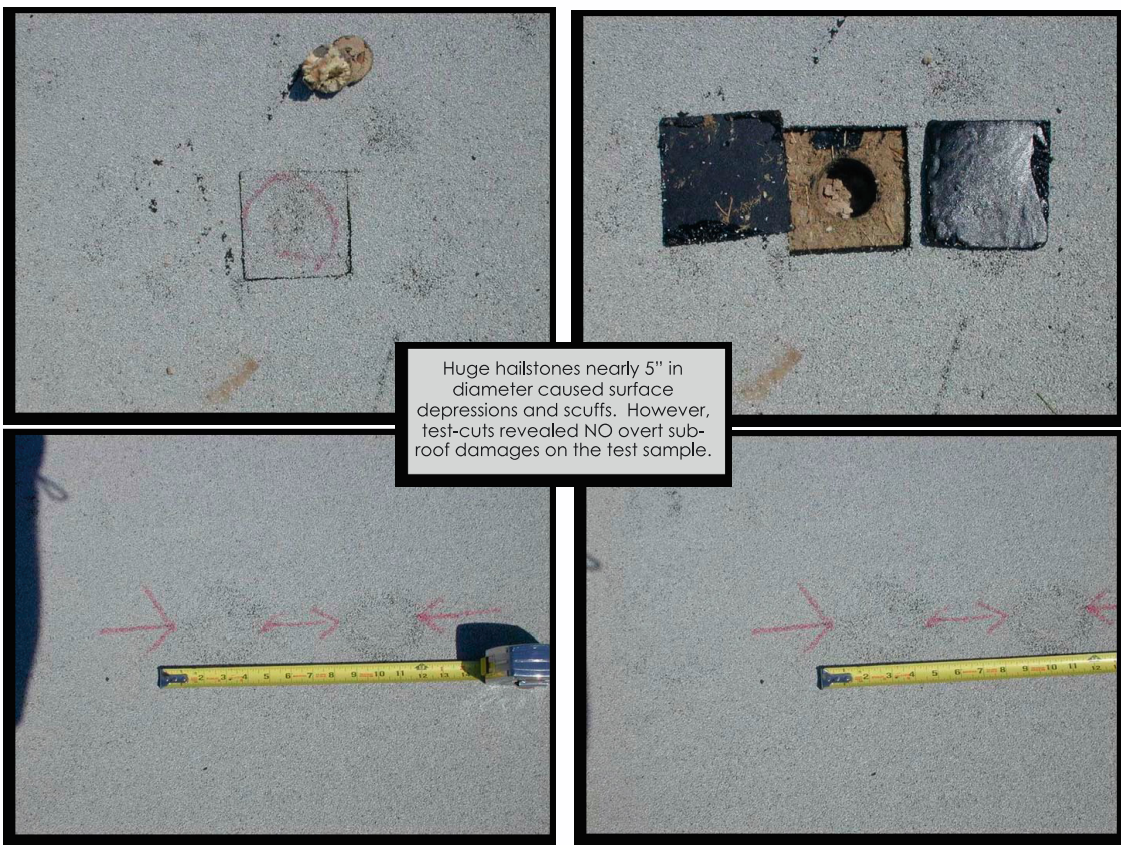
Huge hailstones nearly 5" in diameter caused surface depressions and scuffs. However, test-cuts revealed NO overt sub-roof damages on the test sample.

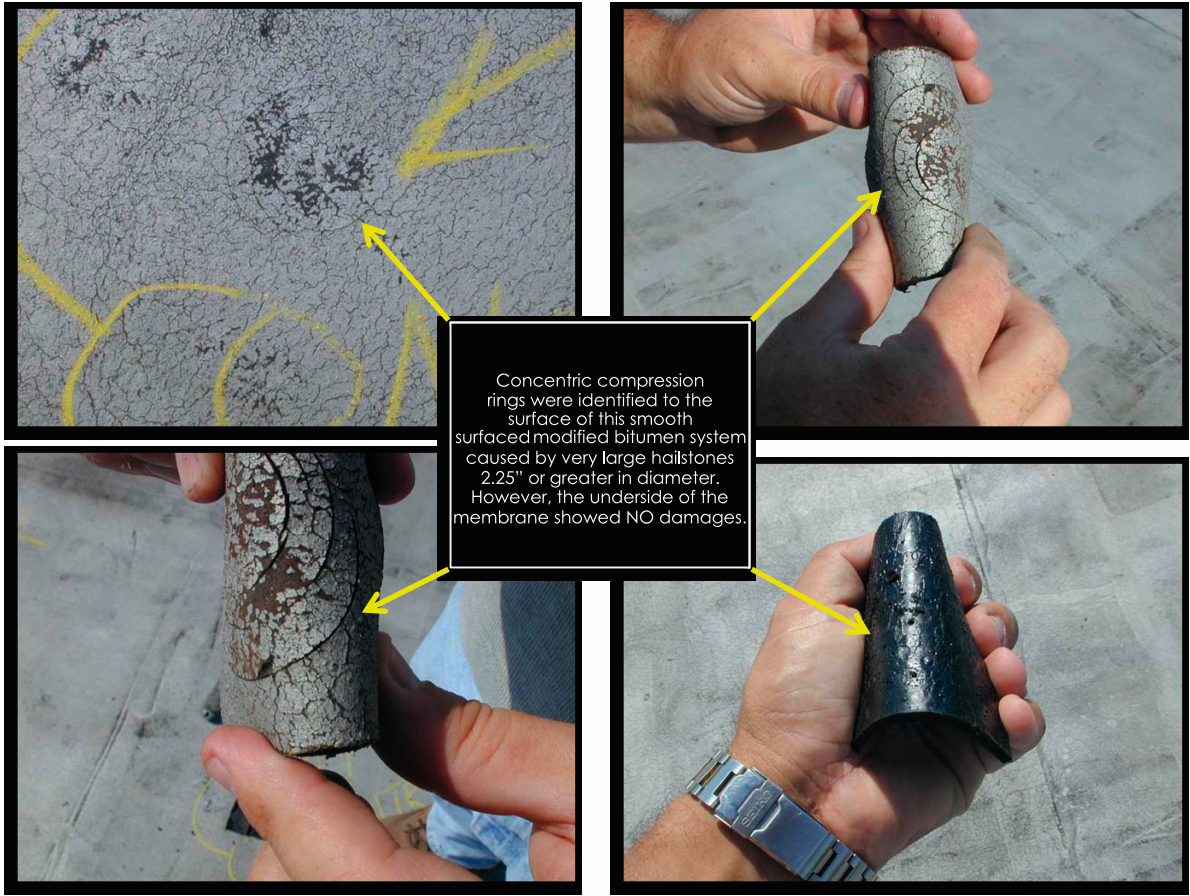
Concentric compression rings were identified to the surface of this smooth surfaced modified bitumen system caused by very large hailstones 2.25" or greater in diameter. However, the underside of the membrane showed NO damages.

However, the very large 2.25" or greater in diameter or larger hailstones which impacted this roof had little or NO detrimental effects to the sub-roof, base-plies or insulation layer in this roof assembly.

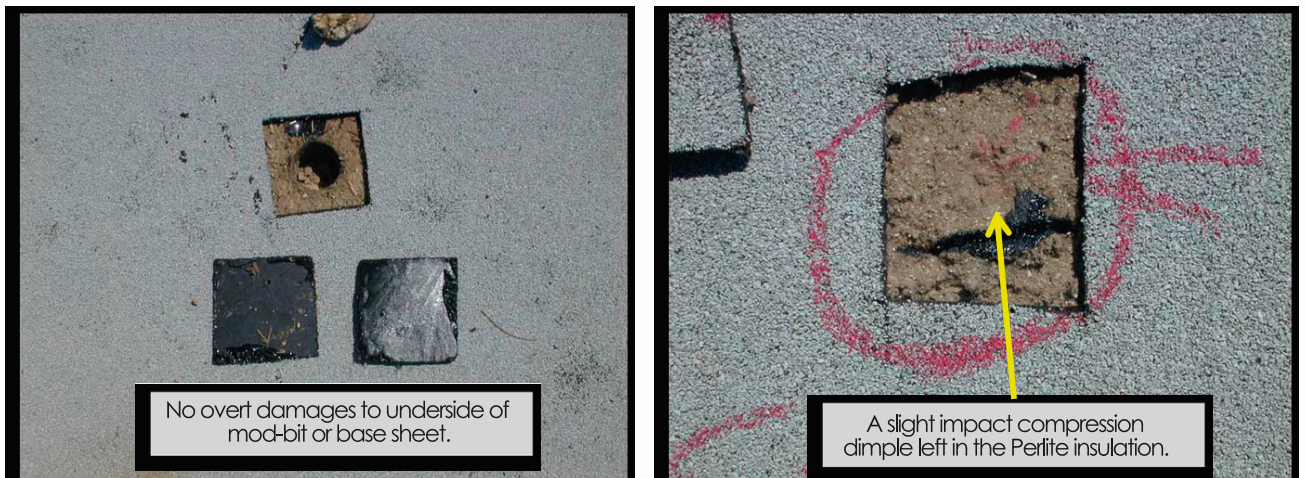
No overt damages to underside of mod-bit or base sheet.

A slight impact compression dimple left in the Perlite insulation.
