Hail Damages to Roof Systems #4 Single Ply Membrane Roof Systems

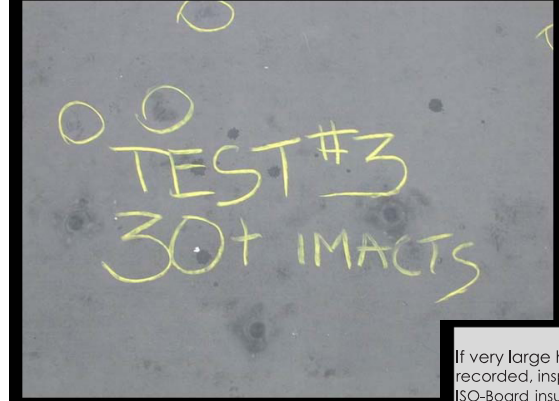
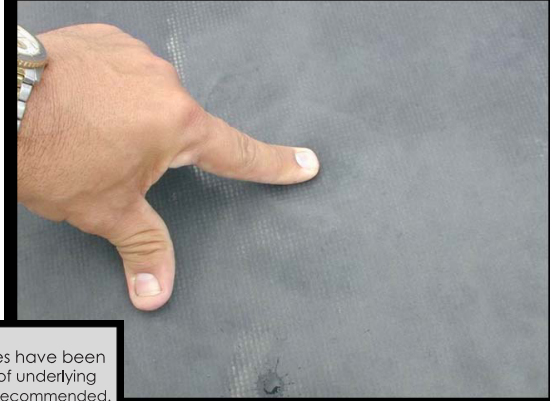
Large damaging hailstones can have devastating effects to single-ply membrane roof assemblies, sometimes without causing direct membrane damages.

Non-reinforced EPDM has great flexibility properties, while underlying insulating substrates, such as ISO-Board, have low impact ratings. This combination can result in damages to the underlying substrate without actually damaging the EPDM membrane.

If hailstones larger than 1.5" in diameter are recorded or suspected, probing of larger splash marks would be recommended to feel for underlying insulation damages.

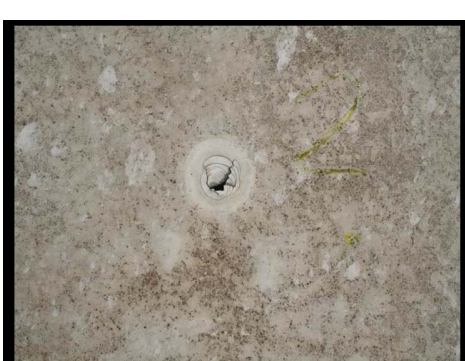
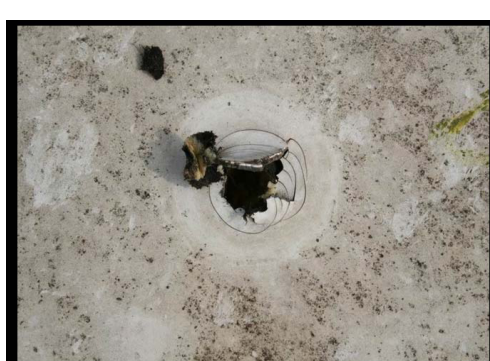
Thermo-Plastic single-ply membranes, especially aged and brittle PVC systems, can be very vulnerable to impact damages.

These photos show isolated membrane fractures within multitudes of splash marks to the surface of the dirty PVC membrane.

However, mere "splash-marks", in-and-of-themselves, on a roof system's surface does not necessarily indicate surface or membrane damages.

However, if large and dense hailstones of at least 1.5" or larger in diameter have been recorded, closer attention should be paid to the larger splash marks.
