GRAYCO

Typical Hail Impact Damages

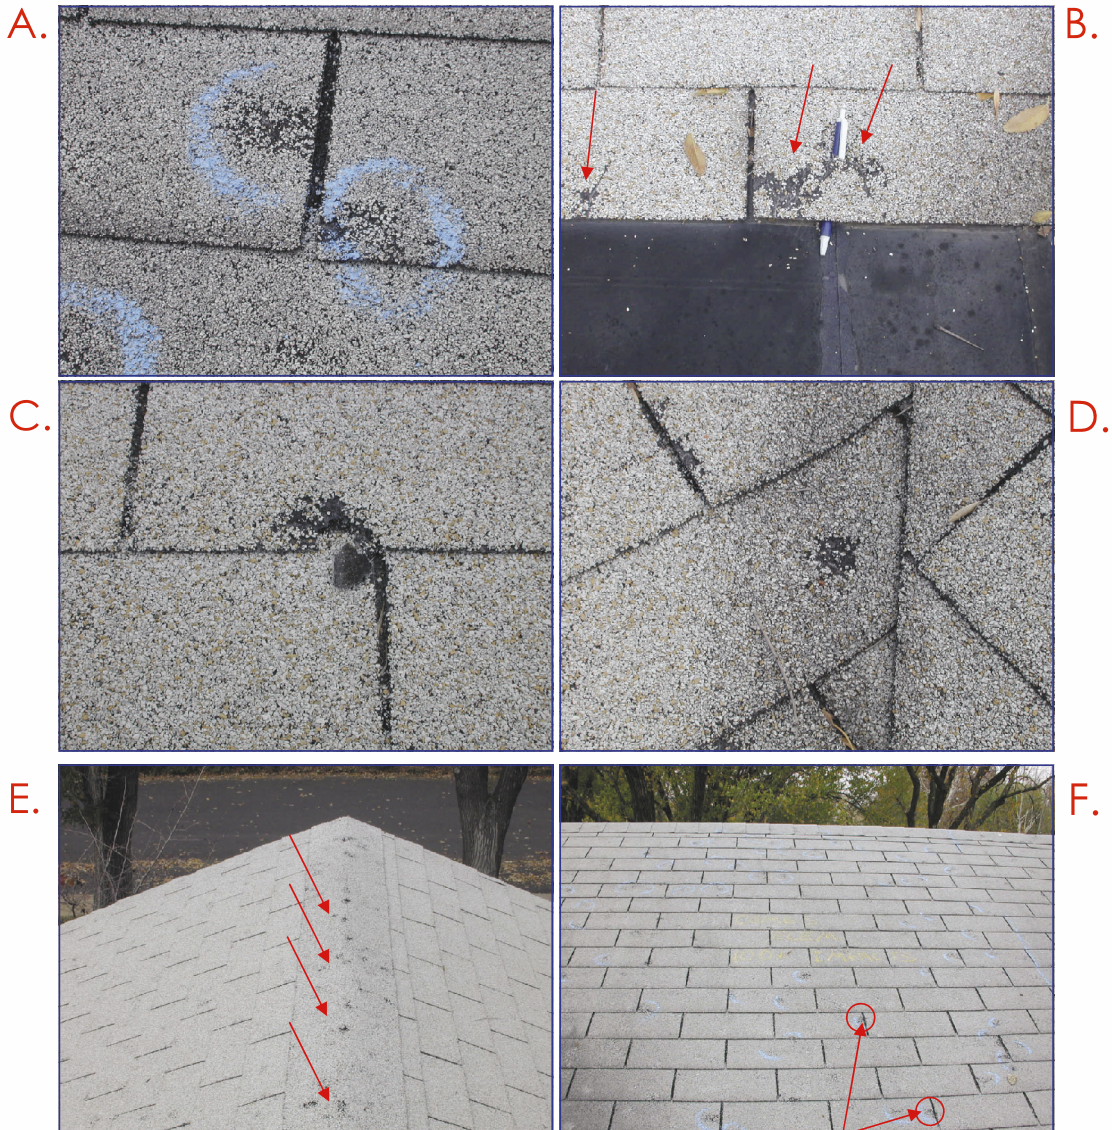
Photo A: Typical random damaging hail impact damage markers.

Photo B: Typical shingle fractures at unsupported eave/gutter edge.

Photo C: A typical shingle fracture located on the shingle's "butt edge."

Photo D: A typical hail impact puncture located in the vulnerable valley area.

Photo E: Typical hail impact damages located on the vulnerable ridge-cap line.

Photo F: Note the randomness of the sizes, locations and frequencies of typical hail impact damages as well as conjoining damages between adjacent tabs.
