HAIL DAMAGE Natural Slate Roof

Hail Damages to Roof Systems #6 Natural Slate Roof Systems

Hail Damages to Natural Slate Roofing

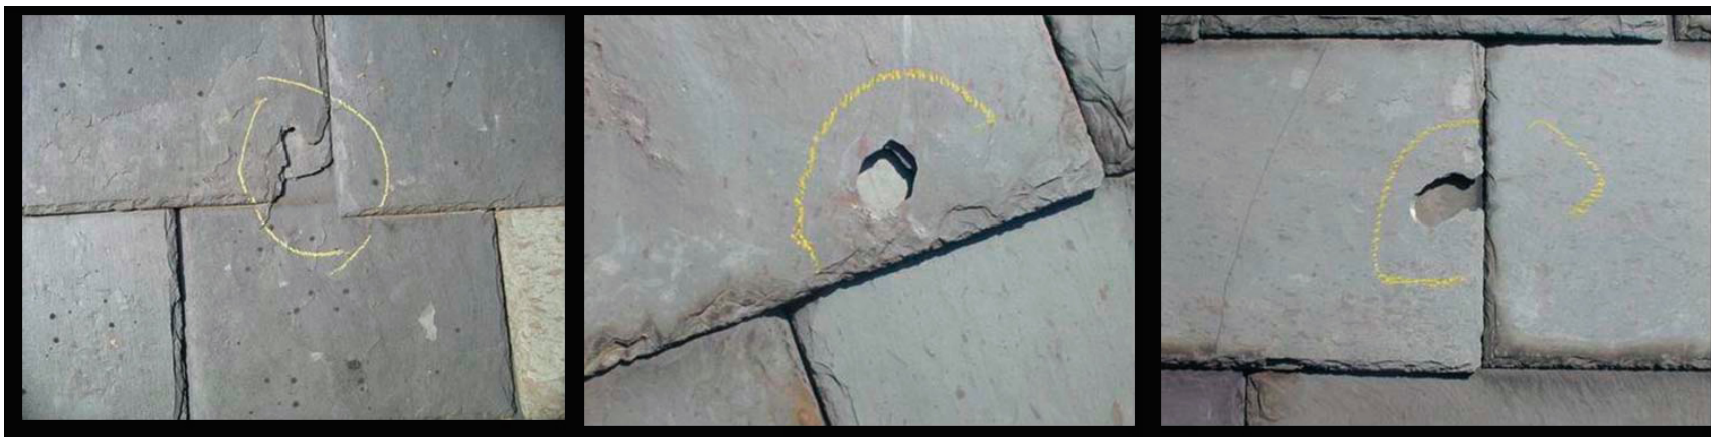
Even very hard S-1 Grade slates (as shown below) can be fractured, punctured and broken by large dense hailstones.

If dense hailstones larger than 1.75" in diameter are recorded or suspected there could be damages to s-1 grade slates.

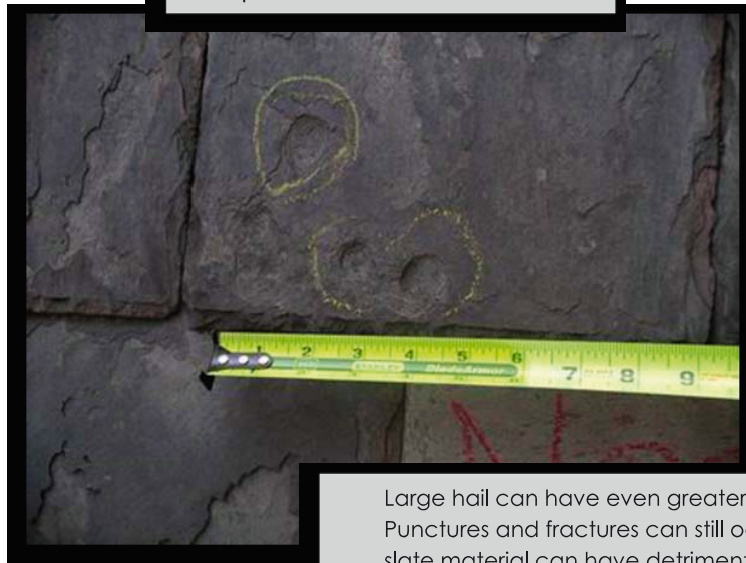
Compression marks in S-2 Slate

Large hail can have even greater effects on older S-1 or softer S-2 Grade slates. Punctures and fractures can still occur, but also compression marks of pulverized slate material can have detrimental affects to the function, life and performance of the natural slate materials. The softened compression marks can absorb moisture and be exacerbated during freeze/thaw cycles.

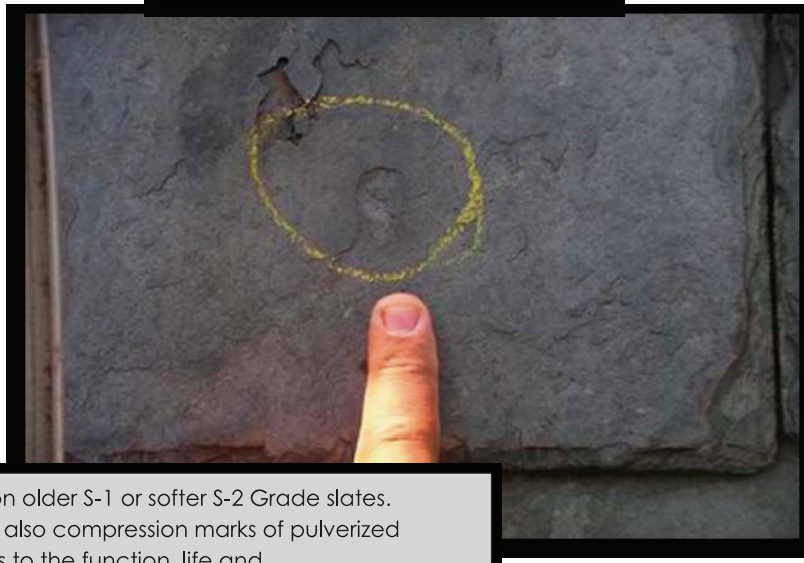
Compression mark in S-2 Slate

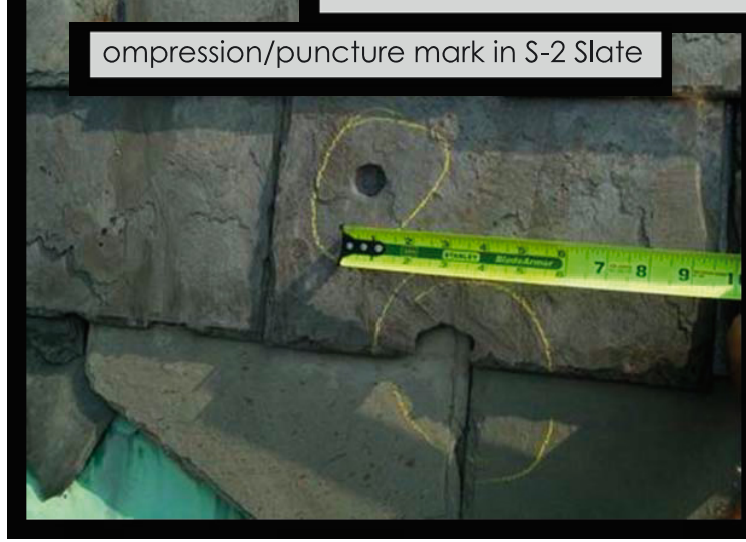
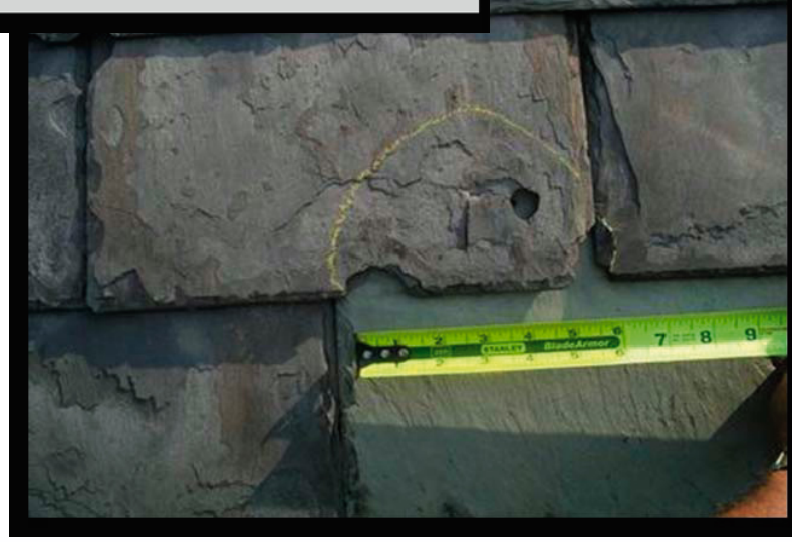
ompression/puncture mark in S-2 Slate

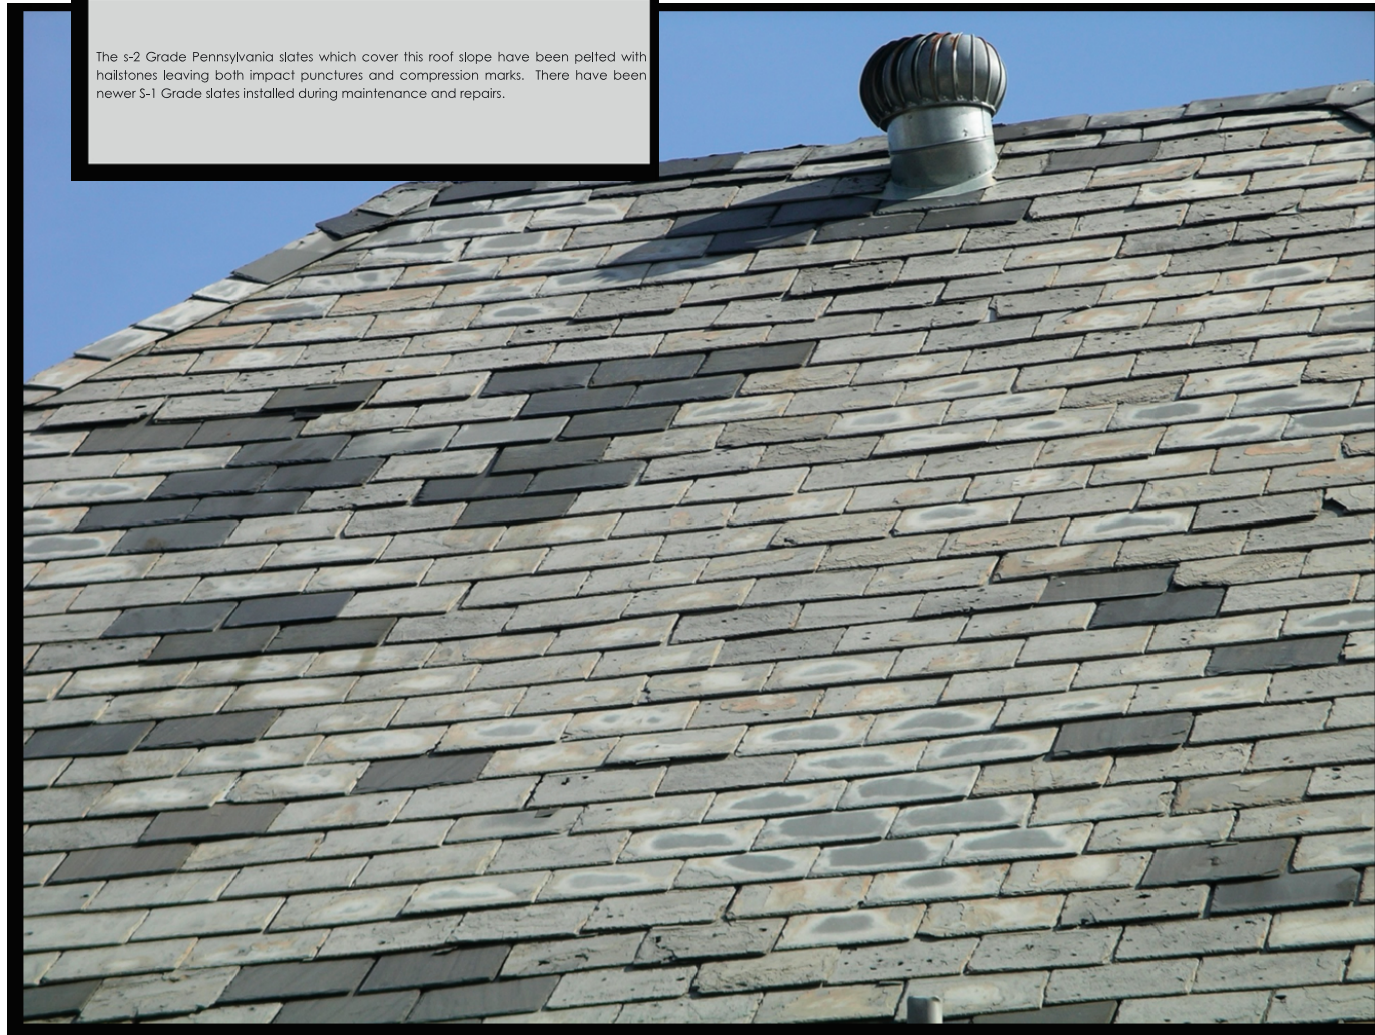
The s-2 Grade Pennsylvania slates which cover this roof slope have been pelted with hailstones leaving both impact punctures and compression marks. There have been newer S-1 Grade slates installed during maintenance and repairs.

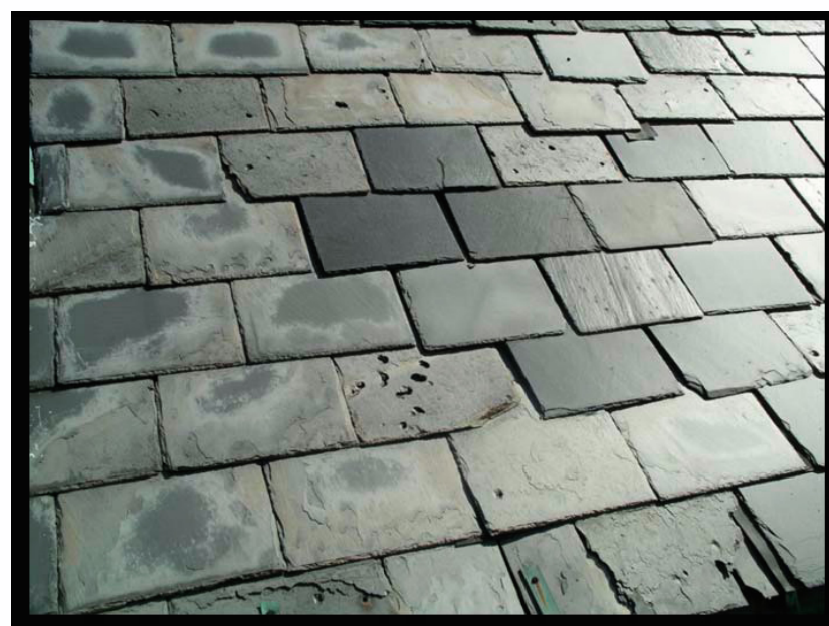
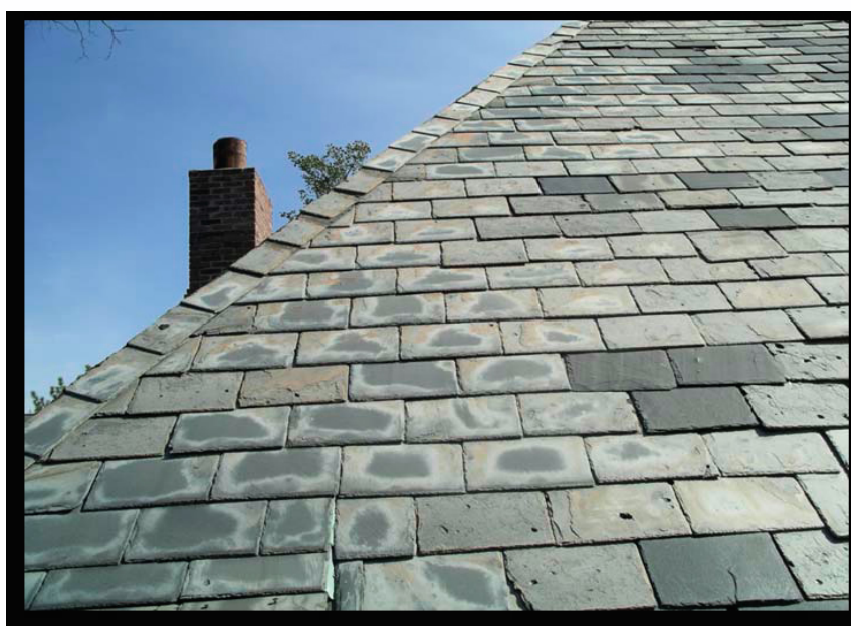
The older, softer S-2 Grade slates show considerably more impact defects than the newer S-2 Grade and the S-1 Grade slates

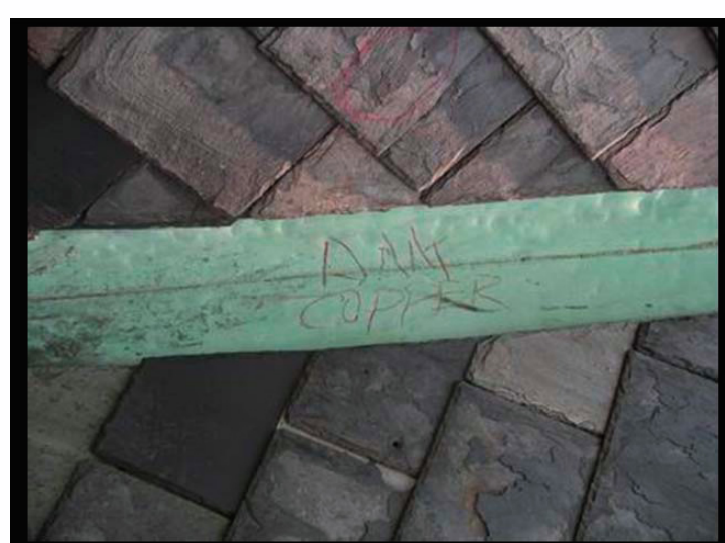
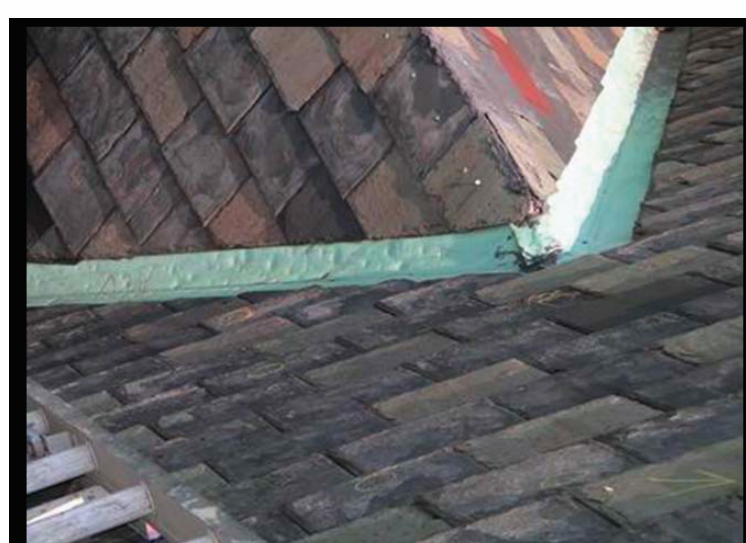
- As with any hail damage analysis and inspection, other exposed materials, such as the soft copper valleys in this case, should be examined for collateral evidence of hail impacts.
- While old copper valleys and older soft metal materials can memorialize even minor past hail events through the life of the roof or flashing systems, large sharp peens can memorialize a singular "damaging" hail event which could have also likely caused clear hail damages to the slates.
- Size and frequency of the larger hail is memorialized in the soft copper.
