## Hail Damages to Roof Systems #5 Metal Roofs and Rooftop Accessories

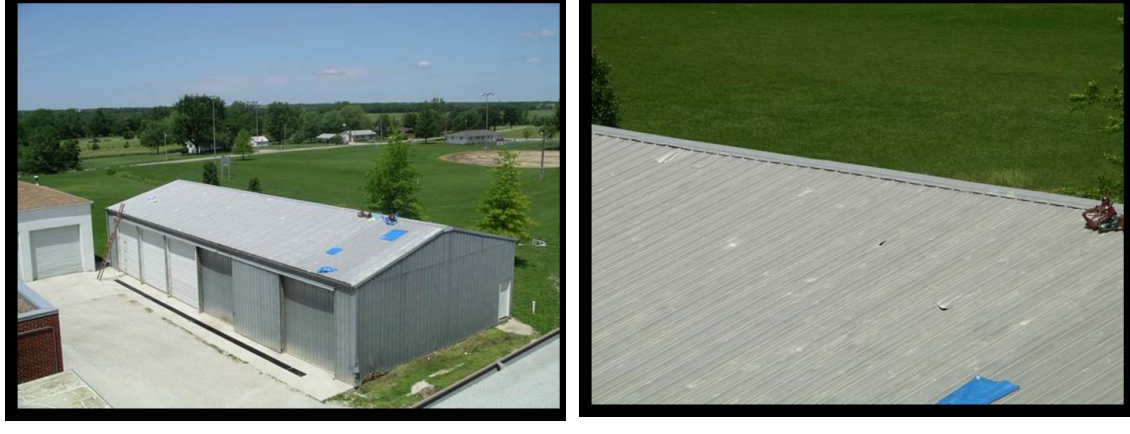
Huge hailstones of up to greater than 5.00" in diameter can cause severe damages and actually punctured this standing seam steel metal roof, leaving large holes the sizes of small footballs.

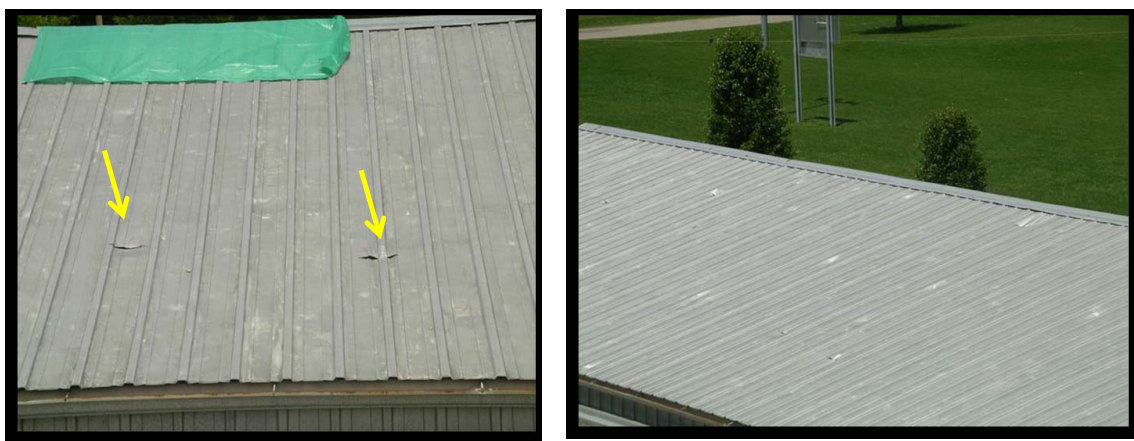
While not all hail dents to rooftop metals are harmful, inspecting these adjacent services can give credence to actual hailstone sizes and the severity of a questioned hail event.

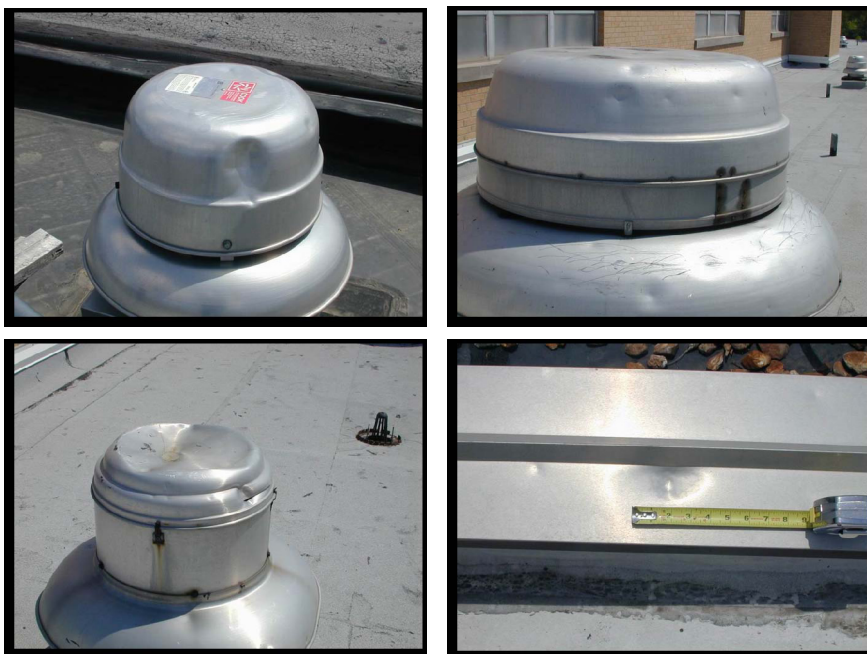
Hail is NOT selective and will impact exterior surfaces. Therefore, other exposed surfaces should also be examined when performing hail damages analysis to roof systems.

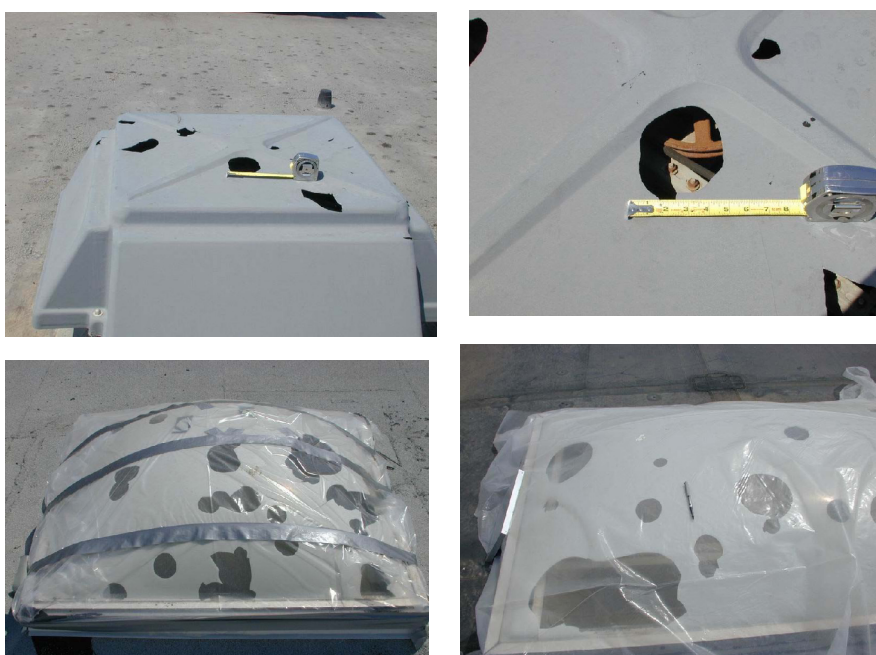
- Soft and vulnerable HVAC cooling fins can memorialize hailstone sizes and frequencies as well, as directional paths of particular hail events.
- Examination of soft, vulnerable exposed materials is recommended to collaborate hail sizes and frequencies which may have impacted the roofing materials.
