Hail Damages to Roof Systems #4 Single Ply Membrane Roof Systems

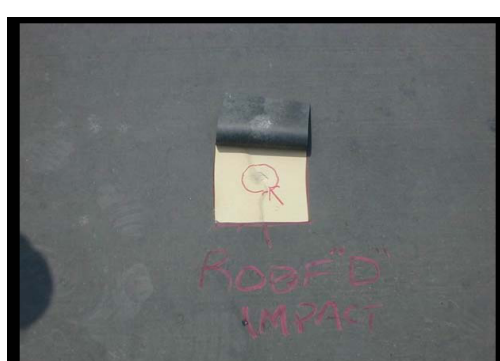
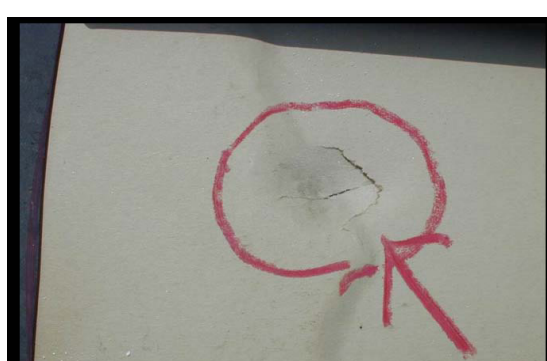
- Very large damaging hailstones can have devastating affects to single-ply membrane roof assemblies, sometimes without causing direct membrane damages.
- Non-reinforced EPDM has great flexibility properties, while underlying insulating substrates such as ISO-Board have low impact ratings. This combination can result in damages to the underlying substrate without actually damaging the EPDM membrane.
- If hailstones larger than 1.50" in diameter are recorded or suspected, probing of larger splash marks would be recommended to feel for underlying insulation damages even to HD type cover boards with higher impact rating.

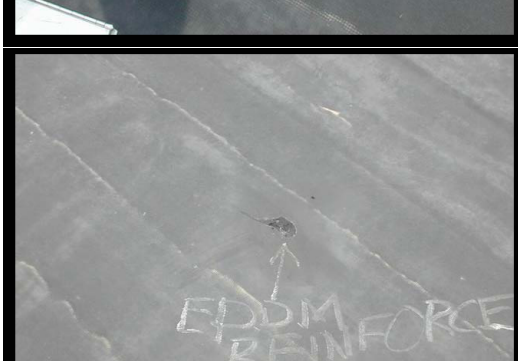
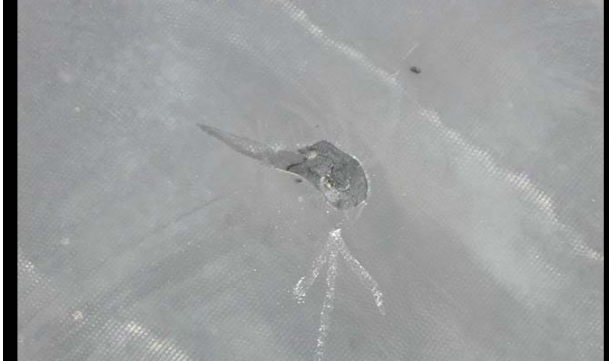
"Reinforced" single-ply membranes, as shown in these photos, can be more susceptible to actual direct hail impact damages due to the lack of flexibility compared to non-reinforced membranes.

Non-reinforced EPDM has great flexibility properties while reinforced membranes have considerable less elongation characteristics. This lack of flexibility can result in damages to the actual single-ply membrane.

If hailstones larger than 1.5" in diameter are recorded or suspected, probing of larger splash marks would be recommended to feel and inspect for membrane fractures.
