HAIL DAMAGE TO ROOFING: ASSESSMENT AND CLASSIFICATION WILLIAM C. CULLEN

National Roofing Contractors Association Washington, D.C.

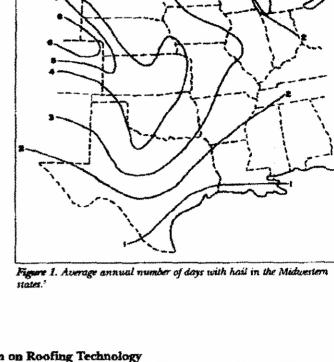
the literature. Hailstorms rarely produce hailstones of uniform size, shape or density. In most cases, these storms produce hailstones that are relatively small and render little danger to roofing materials. However, each year there are rare storms that yield hailstones in the range of 13 to 75 or even 100 mm (% to 3 or even 4 in) in diameter. U.S. Weather Bureau data' show that the most likely areas of the United States to encounter hailstorms lie between the Appalachian and Rocky mountains. A method for predicting the frequency and probability of hail size in the Midwestern states was reported by Friedman.* Figure 1 illustrates the

annual frequency of the number of days on which hail falls that he estimated for the Midwestern states. Using several
